FISH KILL INVESTIGATION:

Indian Creek
Franklin County
Broad River Drainage

By
Anthony Rabern
Fisheries Biologist

October 9, 2019

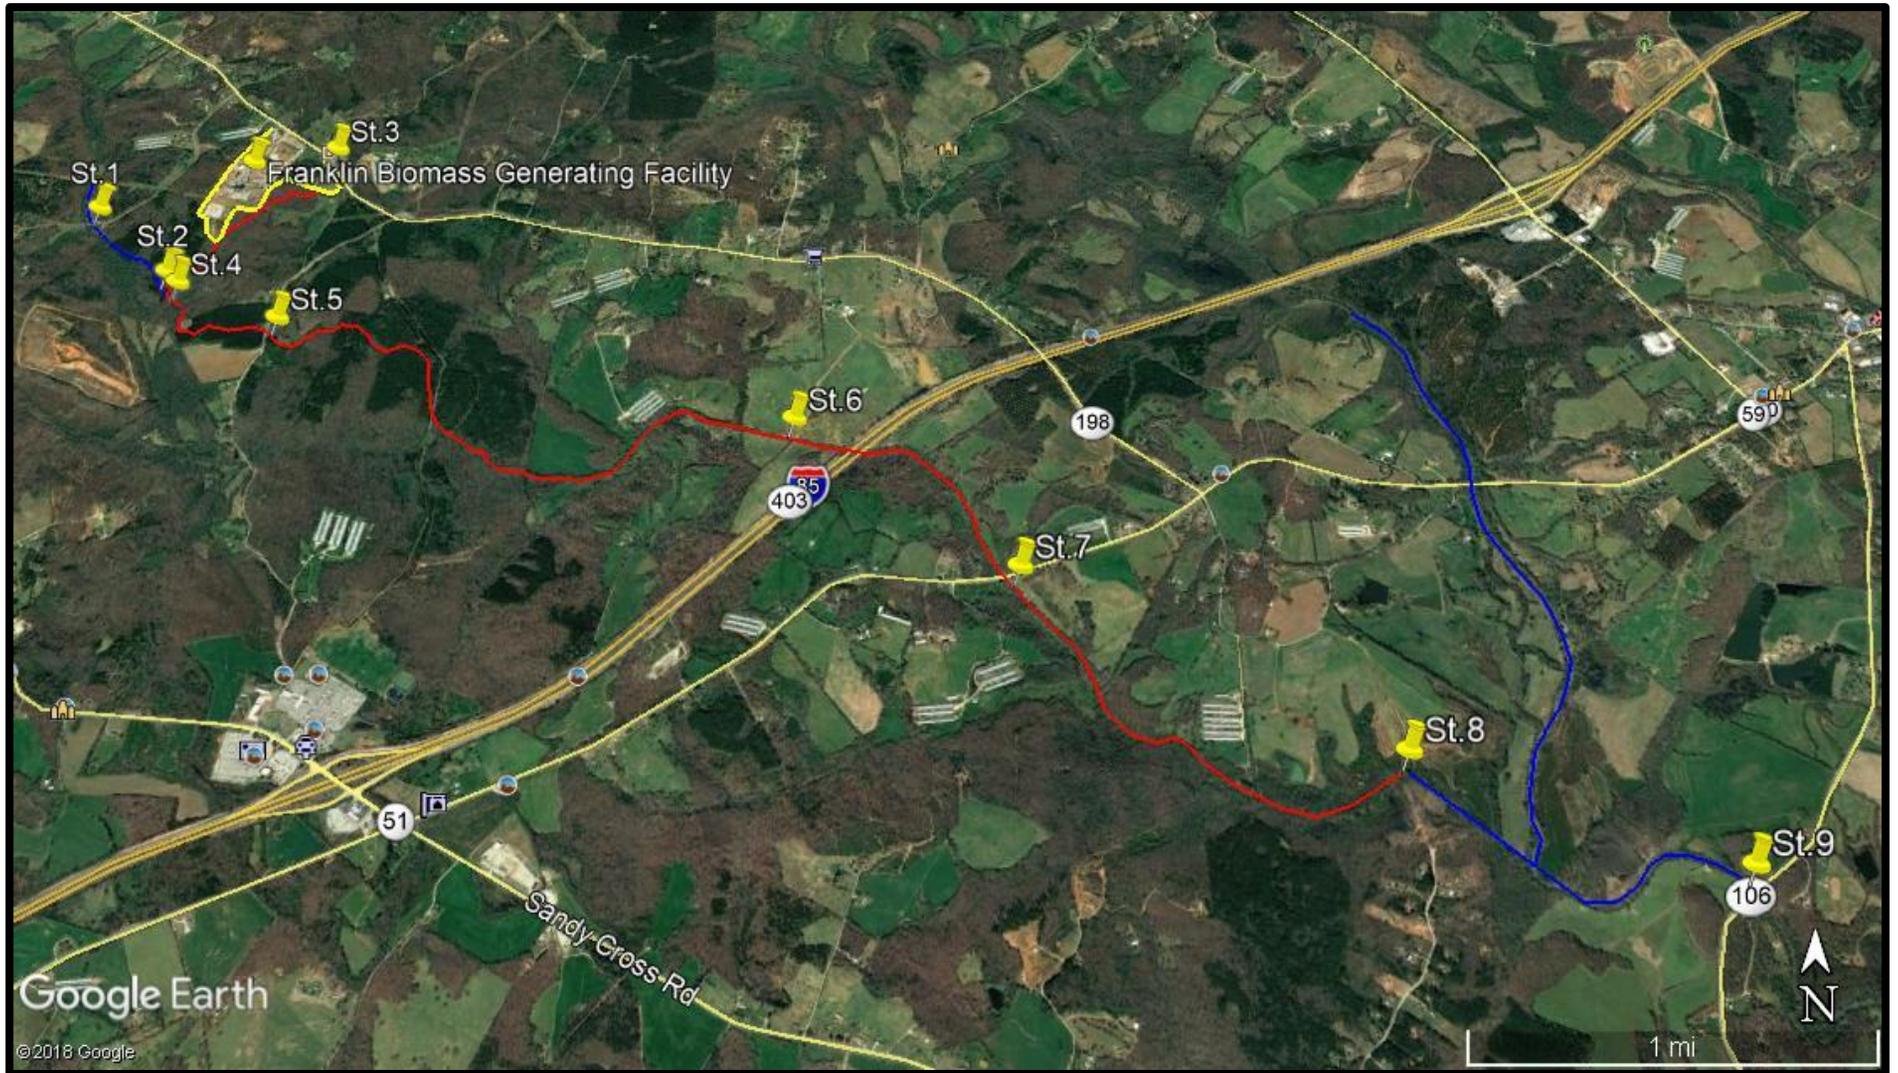
Figure 1. Map of sites visited by WRD Fisheries personnel on October 5-8, 2019 during a fish kill investigation of Indian Creek and an Unnamed Tributary of Indian Creek (Franklin County, Georgia). The red line highlights the fish kill zone. Sites are identified in the text and in Table 1.

On Sunday morning, October 6, 2019, Mr. Anderson located stream access points along Indian Creek and measured water quality at Sites 1, 5, 6, and 7 (Figure 1). In addition, he measured water quality at Site 9 (Figure 1) located in the Middle Fork Broad River downstream of the confluence with Indian Creek. As the day progressed, Mr. Anderson and I established other water quality locations at Sites 2, 3, 4 and 8 (Figure 1). Water quality data measured by Mr. Anderson on October 6, 2019 are summarized in Table 1.

Having established that the upstream terminus of the fish kill zone was at Site 4, Mr. Anderson and I hiked back to our trucks and then drove to each downstream access point along Indian Creek (Sites 5 through 8, Figure 1) to quantify the fish kill using the subsampling procedures outlined in Southwick and Loftus (2017). At each site, we waded approximately 50 m upstream before collecting and enumerating all fish mortalities over a 100 m reach. All fish mortalities were identified to species, enumerated and measured to the nearest inch (Photos 8 & 9). No live fish were observed at Sites 4, 5, 6 and 7; however, a combination of both live and dead fish was observed at Site 8 (Figure 1). Based on the presence of live fish at Site 8 and low numbers of dead fish, we concluded that Site 8 was the downstream terminus of the fish kill zone. To evaluate latent mortality from the black effluent flowing downstream, follow-up monitoring was conducted at Site 8 on October 7, 2019 and at Site 9 on the Middle Fork Broad River on October 8, 2019. No latent mortalities or water quality impacts were observed at these two lower sites.

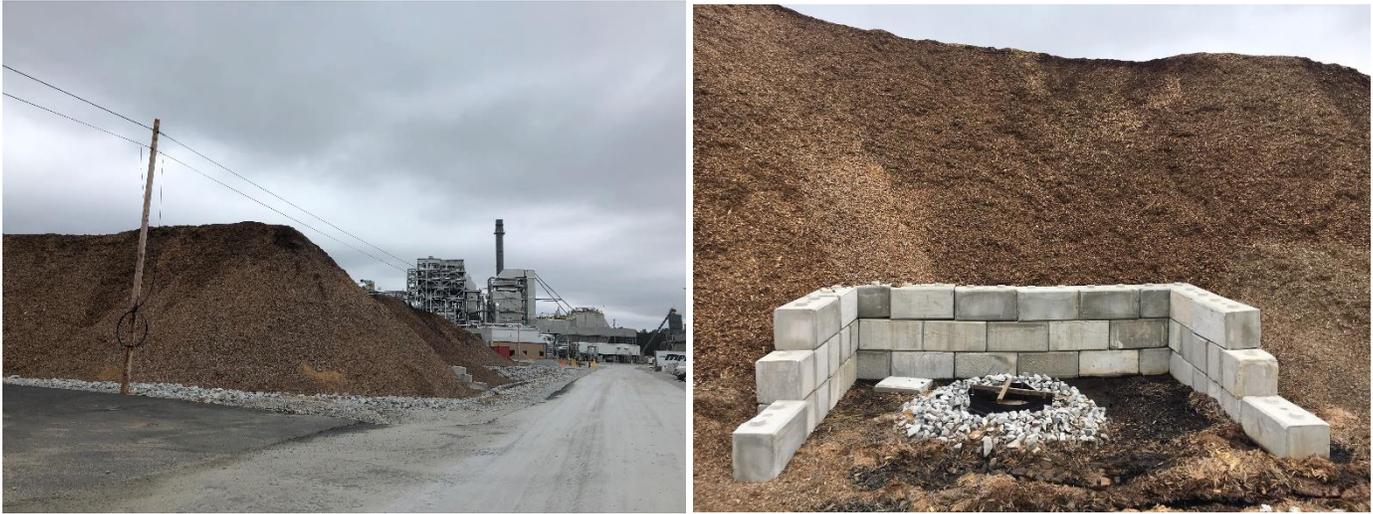
Photos 1&2. Large woodpile at the Franklin Biomass Generating Facility. The photo on the right also shows the catch basin for collecting runoff from the woodpile where black residue from recent runoff was noticeable. Photographs were taken by Anthony Rabern on October 6, 2019.

At 1300 hours on October 6, 2019, Mr. Anderson met me at the Franklin Biomass Generating Facility (FBGF). I spoke with the Operations Supervisor, Mr. Scotty Smith ((252) 813-8804), who put me in contact via his cell phone with the Plant Manager, Mr. David Groves ((910) 477-1198). Mr. Groves explained that the wood pile that fuels the generating facility self-combusted on Saturday afternoon (10/5/19). FBGF staff used large-volume water cannons permanently mounted next to the wood pile to suppress the fire with thousands of gallons of water. Runoff from the water-soaked wood pile overwhelmed the stormwater retention system and overflowed into an Unnamed Tributary that originates on the property and eventually flows into Indian Creek (Photos 1-4). While at the facility, I observed a light amount of smoke billowing from the wood pile. I also observed residual runoff from the wood pile that was black in color.

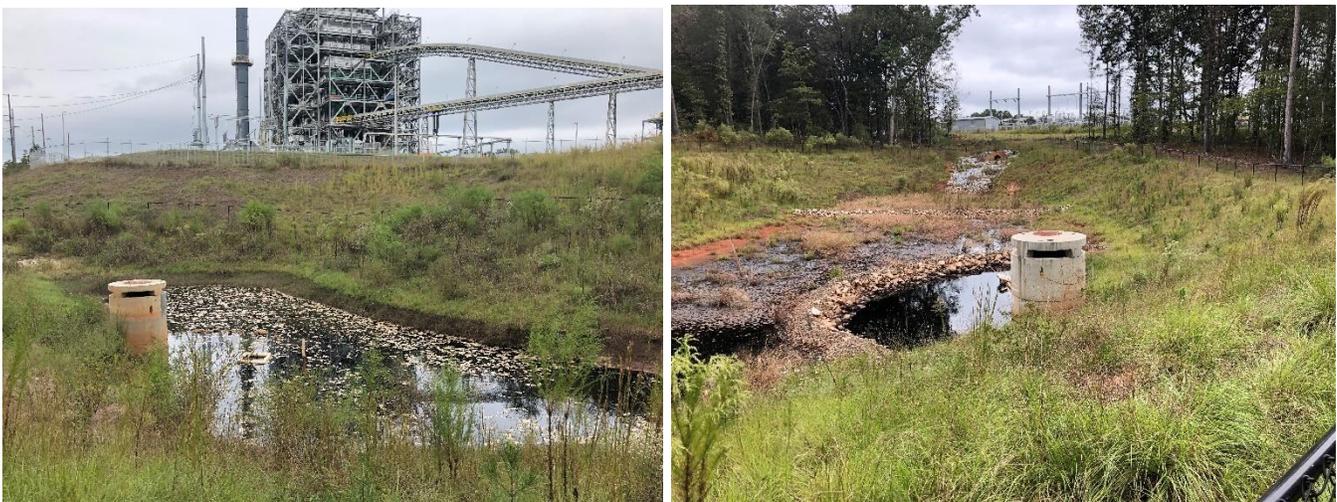
Photos 3&4. Two stormwater retention ponds at the Franklin Generating Biomass Facility with each pond containing black water. Photographs were taken by Anthony Rabern on October 6, 2019.

Mr. Anderson and I proceeded to Site 3 (Figure 1), located in the stormwater drainage system, to measure water quality in the black runoff from FBGF. We followed the stormwater retention system downstream and observed black effluent flowing from the retention pond and into the Unnamed Tributary of Indian Creek (Photo 5). The water in the Unnamed Tributary of Indian Creek was black in color and clarity was zero (Photo 6). Because of this black color, we were not able to visually ascertain the presence/absence of aquatic organisms in the Unnamed Tributary of Indian Creek nor use the Hach Kit to measure pH and total hardness. We followed the Unnamed Tributary of Indian Creek downstream for approximately 0.7 miles to its confluence with Indian Creek. Just upstream of the confluence of the Unnamed Tributary of Indian Creek with Indian Creek proper at Site 2 (Figure 1), the water was clear and live fish were abundant (Photo 7). Water quality parameters (temperature, dissolved oxygen, pH, and total hardness) at Site 2 were suitable to support aquatic life and the water chemistry at this location as well as at

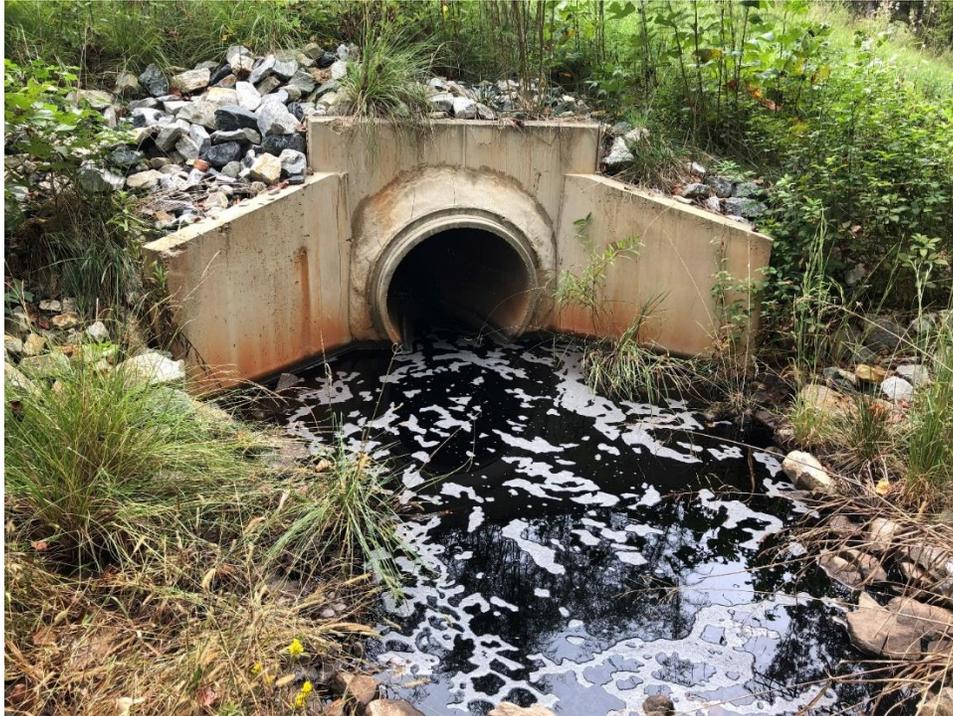
Photo 5. Stormwater retention pond outlet at the Franklin Generation Biomass Facility releasing black effluent into the Unnamed Tributary of Indian Creek. Photograph was taken by Anthony Rabern on October 6, 2019.

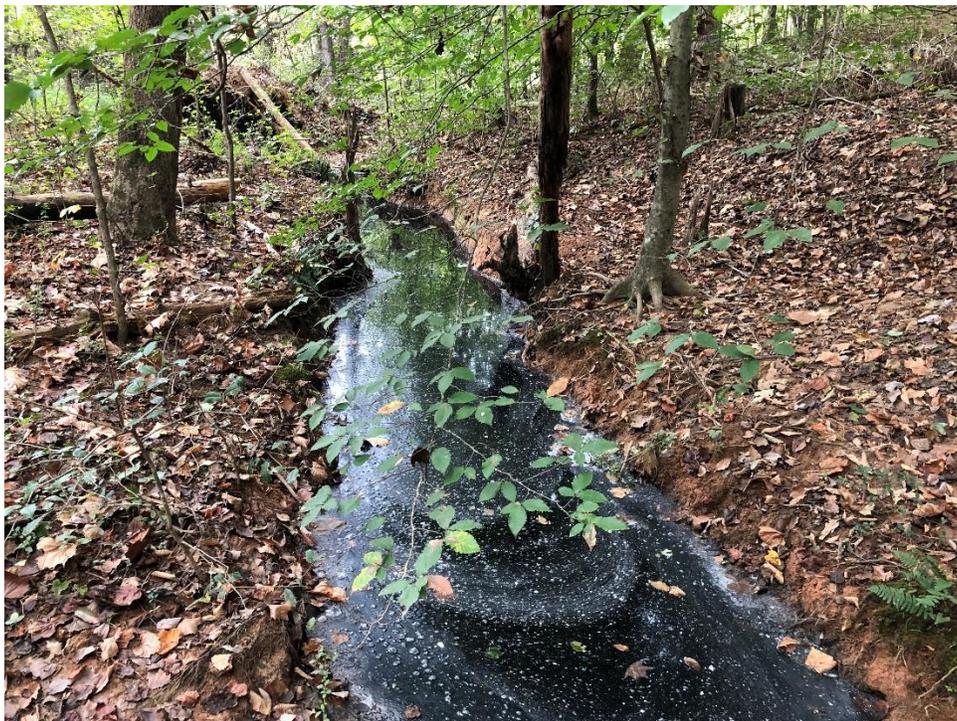
Photo 6. Unnamed Tributary of Indian Creek containing black effluent from Franklin County Generating Facility's retention ponds on October 6, 2019. Photograph was taken by Anthony Rabern.

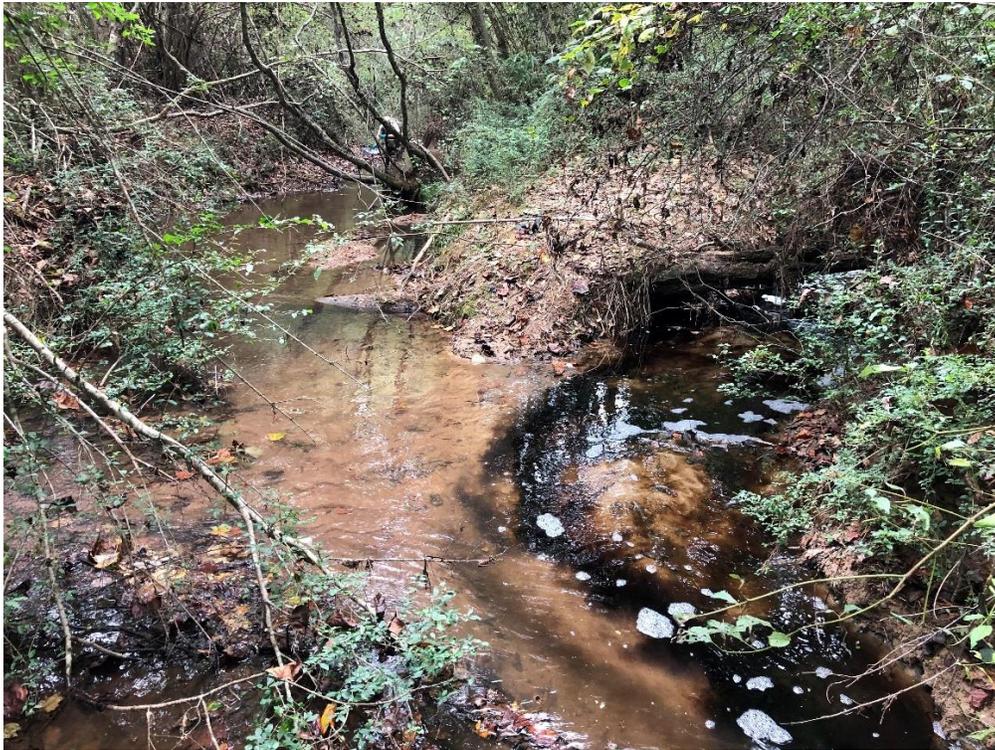
Photo 7. Confluence of Indian Creek (left) and the Unnamed Tributary of Indian Creek (right) that drained the Franklin Biomass Generating Facility’s retention ponds. Photograph taken by Anthony Rabern on October 6, 2019.

The first fish mortality was observed at Site 4 (Figure 1) in Indian Creek, which was located about 25 m downstream from the confluence with the Unnamed Tributary of Indian Creek. Although Site 2, upstream of the confluence, and Site 4, downstream of the confluence, were only 50 meters apart, a significant change in water quality was measured between these two stations. At Site 4, the pH decreased by four units, total hardness increased by 500% and dissolved oxygen decreased by 1.2 mg/L. In addition, there was a dramatic color change at Site 4 from clear to black and a strong odor like that of burnt wood.

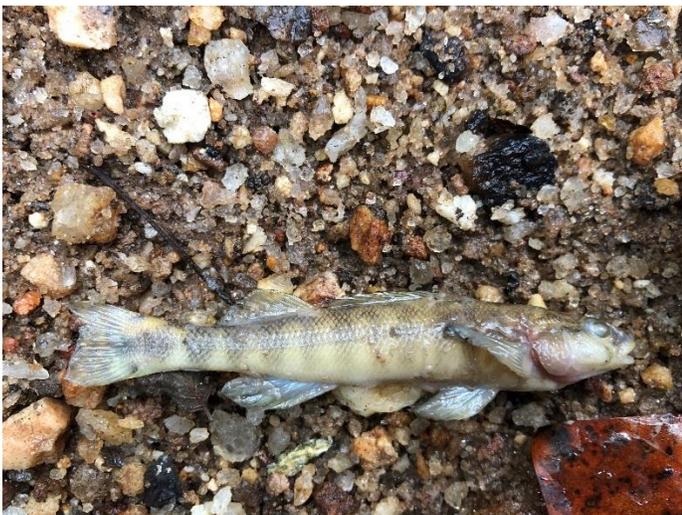
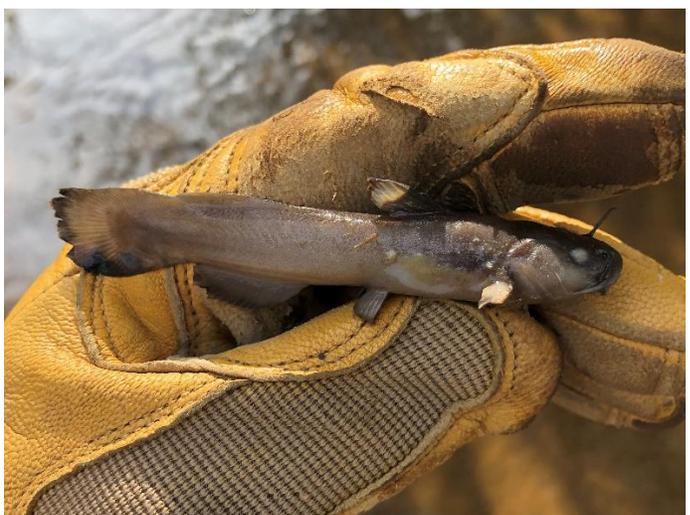
Photos 8&9. Fish mortalities collected by Anthony Rabern in Indian Creek downstream of the Unnamed Tributary of Indian Creek on October 6, 2019. Photographs were taken by Anthony Rabern.

Based on the findings from our water quality measurements, visual stream observations and fish counts on October 6, 2019, a total die-off of fish occurred in 4.6 miles of Indian Creek. The fish kill was caused by significant water quality changes in Indian Creek associated with run-off from a smoldering wood pile at FBGF. The resulting black effluent that drained from FBGF into Indian Creek significantly reduced pH and dissolved oxygen concentrations in a very short time period to levels that were potentially lethal to fish in the 4.6-mile impact zone. The total number of fish mortalities in Indian Creek on October 6, 2019 was estimated to be 2,159 fish (Table 2), which included seven species of fish including those pictured in Photos 8 and 9. The total number of fish mortalities was estimated by expanding the total number of fish collected in each 100 m subsample reach over the total distance for each reach. Expanded fish counts were then summed for all subsample reaches to provide a total fish mortality estimate. Using the replacement values of fish reported in Southwick and Loftus (2017), the monetary value of these fish mortalities totaled \$1,428.67. Investigative costs for personnel and vehicles used in this fish kill investigation totaled \$3,366.78 (Table 3). The investigative costs plus monetary value of fish brought the total cost of the fish kill to \$4,795.45.
