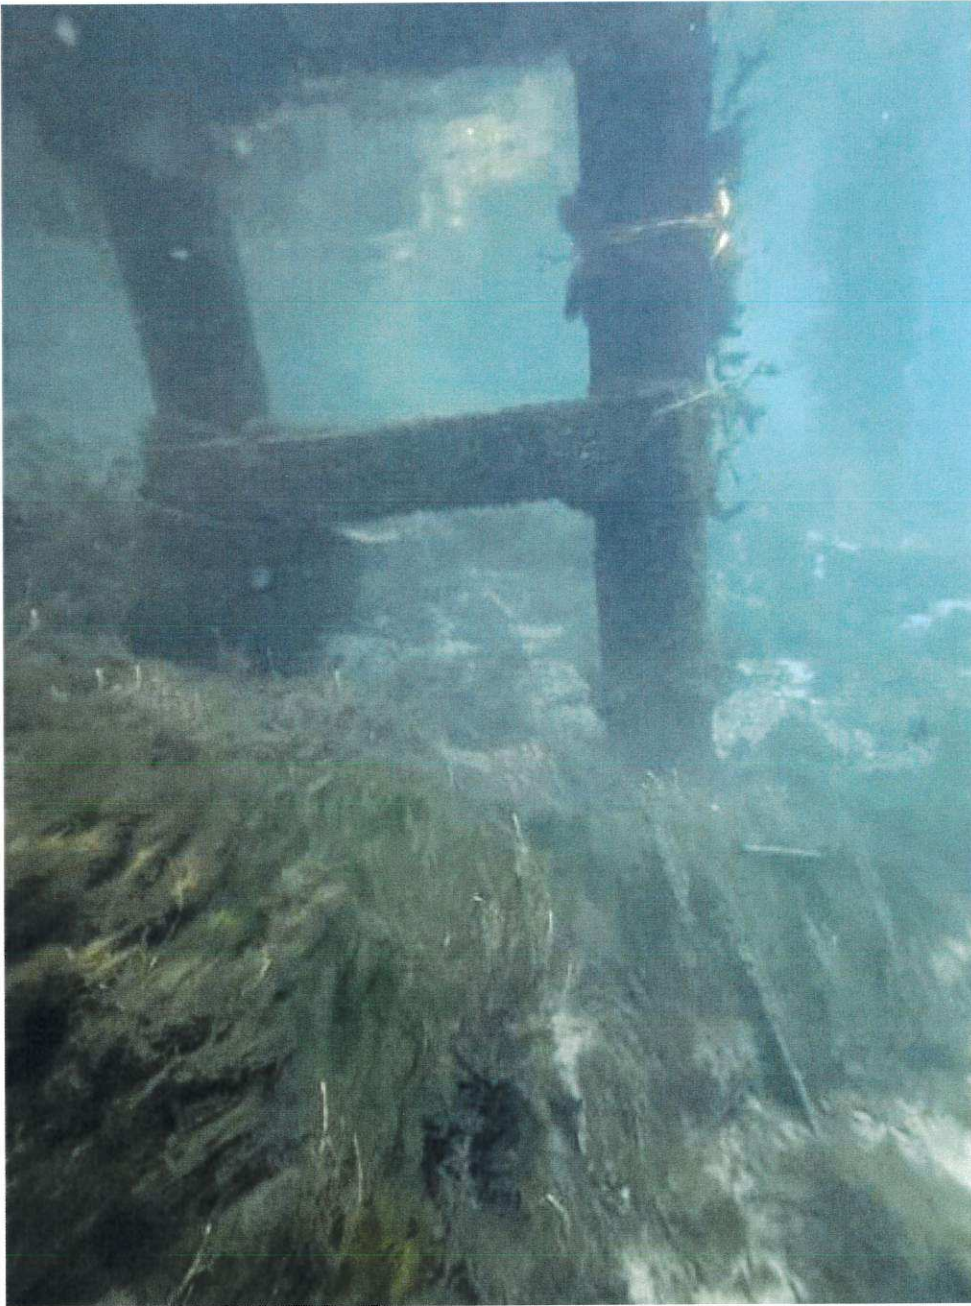
Figure 2: 09/06/2025. Submerged aquatic vegetation primarily consists of filamentous algae. Loss of soil around pilings beneath private dock at 218 SW Riverside Ave, Fort White, FL.
